AAA **Inspection Specialties Inc.**

PROPERTY INSPECTION REPORT

Concerning: 7777 Any Street, Houston

8/4/2009

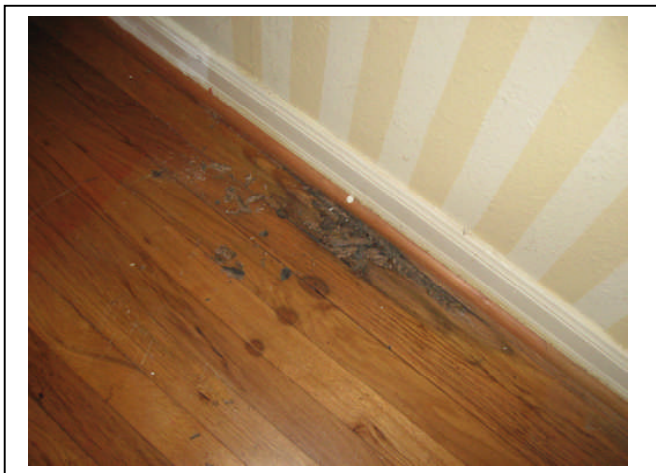
- There was wood rot observed at the back bedroom floor. This appears to be consistent with a leaking kitchen sink drain. Any damaged floor decking should be replaced.

Picture 1 Back bedroom floor wood rot

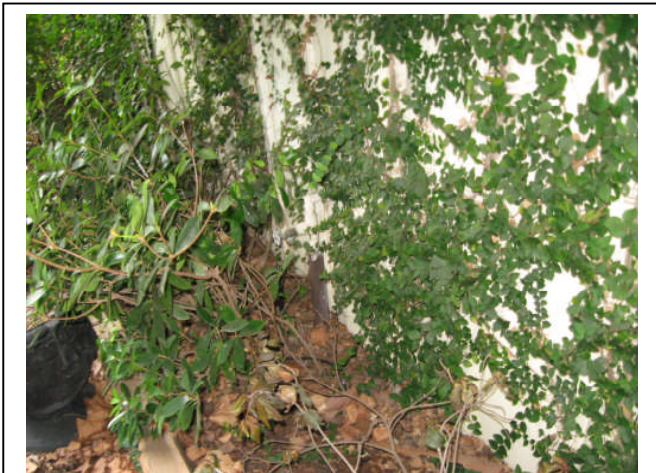
- There is wood rot observed at the left side fire place exterior press-board siding. Any damaged wood should be replaced and the new siding or trim painted and sealed to prevent further deterioration.
- There is dense vegetation observed growing up the house front exterior porch. This greatly limits access to the house front wall and foundation perimeter. The vegetation should be trimmed and removed to allow access and limit possible wood destroying insect infestation.

Picture 2 Front wall dense vegetation

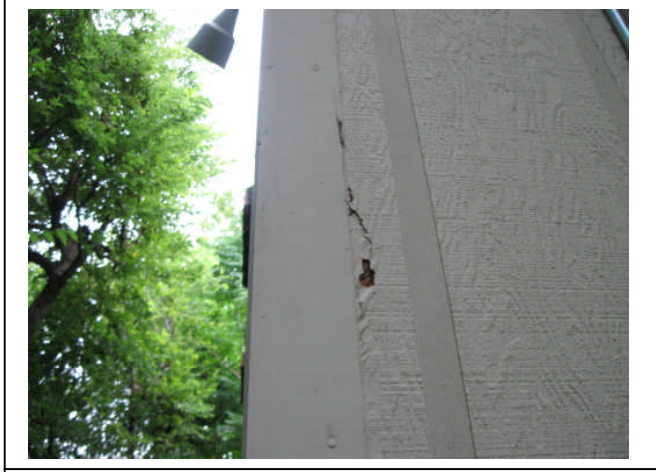
Picture 3 Living area chimney wood rot

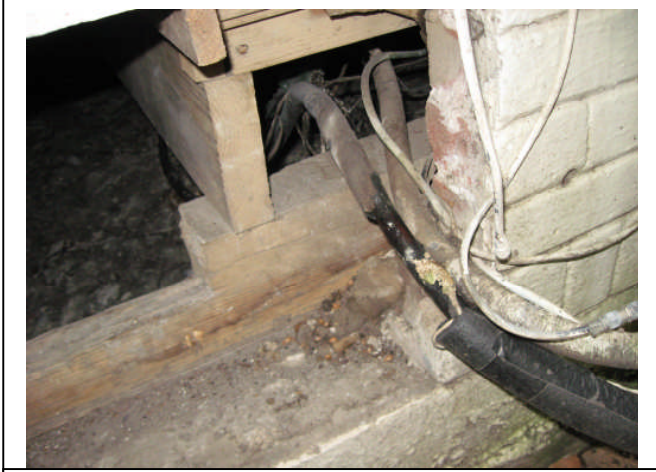
- There is missing insulation at the 1st floor system A/C evaporator main drain and Freon lines. The missing insulation should be replaced to prevent condensation from forming.
- The 1st floor A/C condensate line is improperly open at the house left side perimeter. This allows moisture to stand at the exterior. The condensate drain line should be connected to the house plumbing system.
- There was a low reading of less than 16 degrees for the 1st floor A/C system differential measured across the evaporator coil. This is an indication of possible low freon. Consult an A/C technician to check the system and make

Picture 4 Missing Freon line insulation

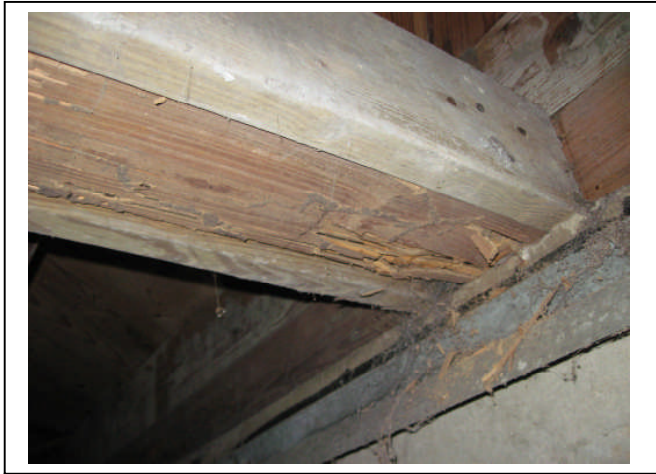
- There are signs of wood destroying insect damaged and partial repair at the front sub-floor crawl space beams. Although this does not appears to be affecting the adequacy of the floor structure, any insect damaged or damaged wood should be repaired.

Picture 5 Front sub-floor damaged beam

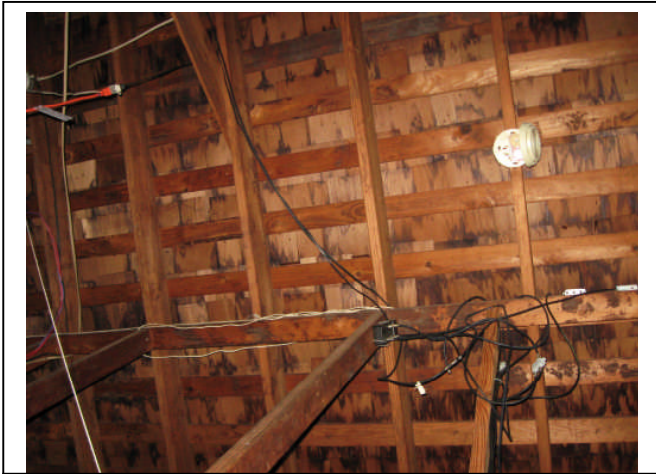
- There are composition shingles observed installed over a cedar shingle original decking. This is not an approved decking material and could affect the insurability of the house. The roof should be replaced and an approved decking material installed. The buyer should consult their insurance provider for insurability of the roof system.
- There is minor damage observed at the back roof plumbing vent pipe flashings. The damaged roof jacks should be repaired and properly sealed to prevent moisture penetration and damage.
- There is an aggregate low slope roof observed at the house front porch with signs of moderate deterioration. The roof aggregate is partially missing leaving the membrane exposed. The damaged roof should be repaired or replaced.

Picture 6 Cedar shingles roof decking

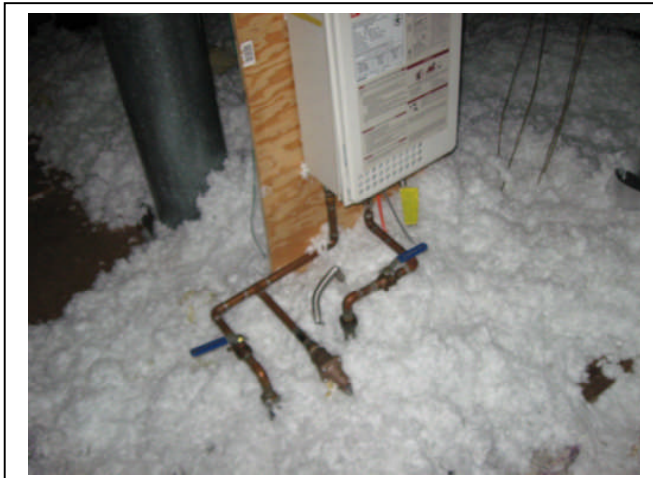
- The water heater is located at the attic with no safety pan. There should be a safety pan installed under the water heater. The safety pan drain pipe should be installed and terminated near grade level.
- The water heater power supply is improperly connected with an extension cord wire to an attic ceiling light fixture. The water heater power supply circuit should be properly wired.

Picture 7 Missing water heater safety pan

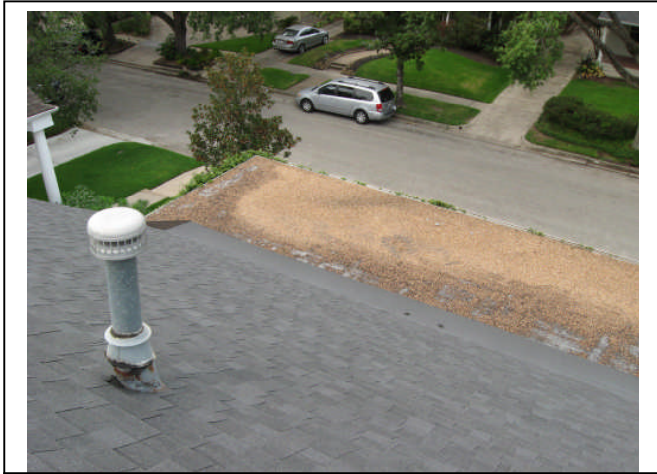
Picture 8 Front roof exposed membrane

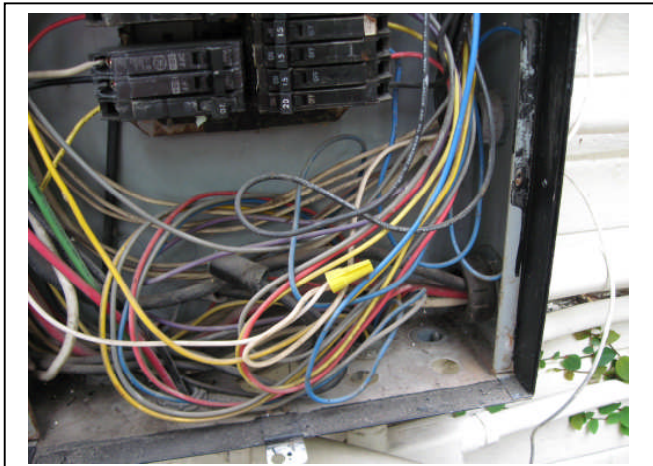
- There are missing knock out slots at the breaker panel base. Any missing breaker panels knock out slots should be replaced.

Picture 9 Missing knock out slots

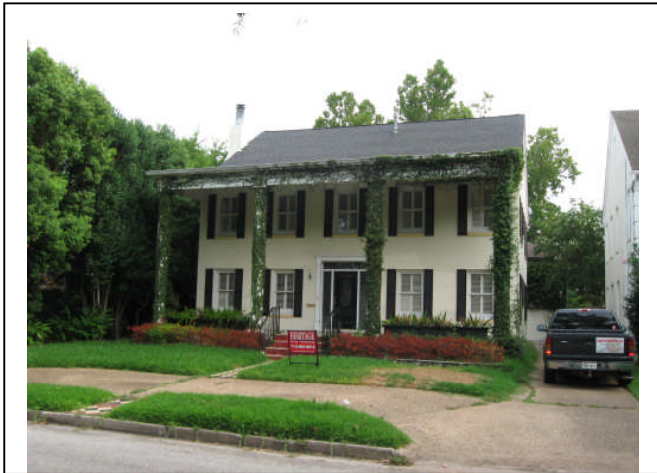
Picture 10 Front exterior vegetation
